PrintServer 17/600 Printer

Maintenance Advisory

EK-PRT17-MA. A01

First Printing, March 1994

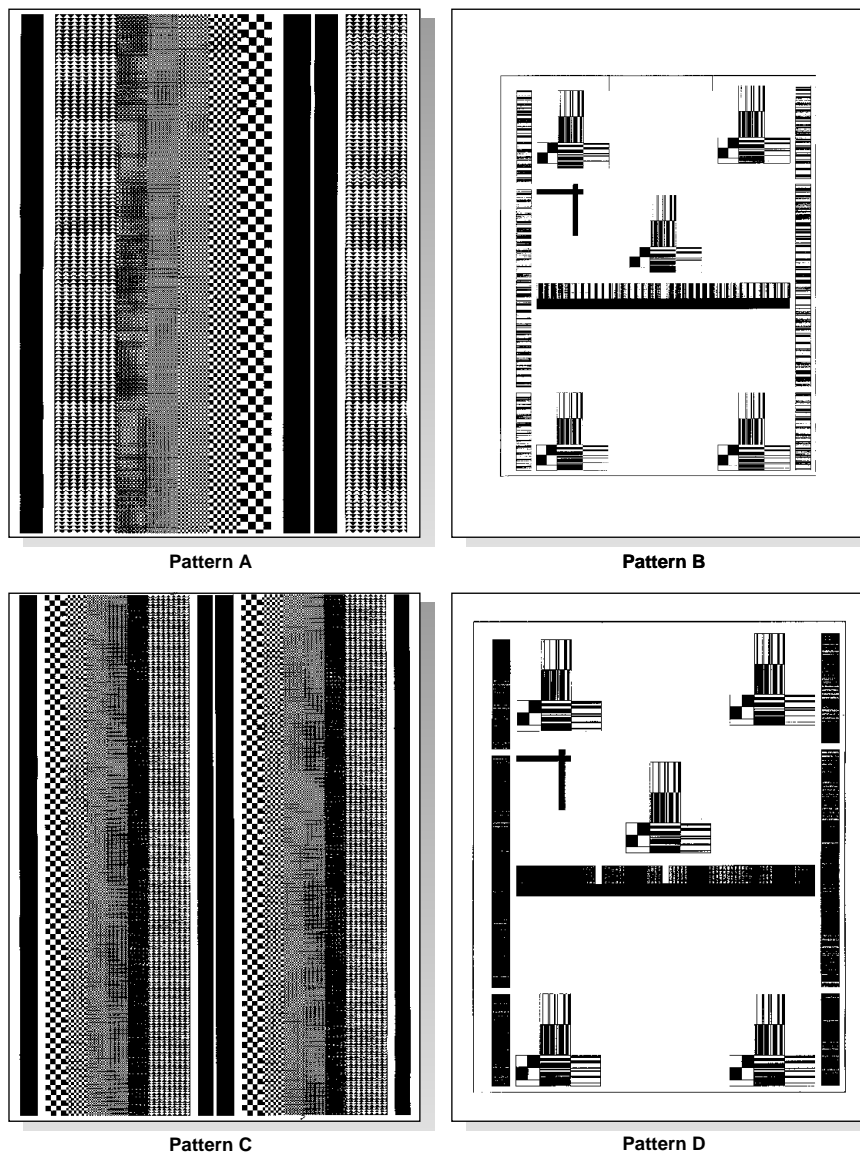
Figure 2–1 New V2.1 Controller Board Test Patterns

Figure 2–1 shows the 400 and 600 dpi test patterns that are printed by a PrintServer 17/600 printer. An example of the PrintServer 17 300 dpi pattern appears in Figure 4-2 of the service guide.

- Patterns A and B are printed at 400 dpi. Compare the B and D test test patterns. Notice how the B pattern is smaller on the page than pattern D. This only happens at 400 dpi.
- Patterns C and D are printed at 600 dpi. Compare the C and the A test patterns. Notice how the C test pattern is horizontally compressed. This compression effect increases as the density (dots-per-inch) increases.
